References for the Science vessel workshop participants

Anchor Strike: April 2018 ITB Clyde S VanEnkevort/Erie Trader with Underwater Cables and Pipelines, Straits of Mackinac

Anchor Contact of Articulated Tug and Barge *Clyde S VanEnkevort/Erie Trader* with Underwater Cables and Pipelines

LOCATION
STRAITS OF MACKINAC, MICHIGAN, ABOUT 2 MILES WEST OF MACKINAC BRIDGEACCIDENT DATE
APRIL 1, 2018REPORT NUMBER
MAB 19/12ACCIDENT ID
DCA18FM019ISSUED
MAY 21, 2019

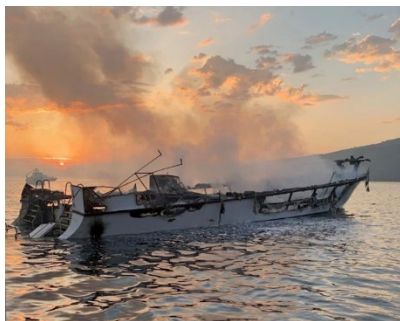
Photo: Ventura County Fire Department

The NTSB said the Conception's captain failed to post a roving night watchman, which allowed the deadly fire to quickly spread.

Thirty-four passengers and crew died in the dive boat Conception fire.

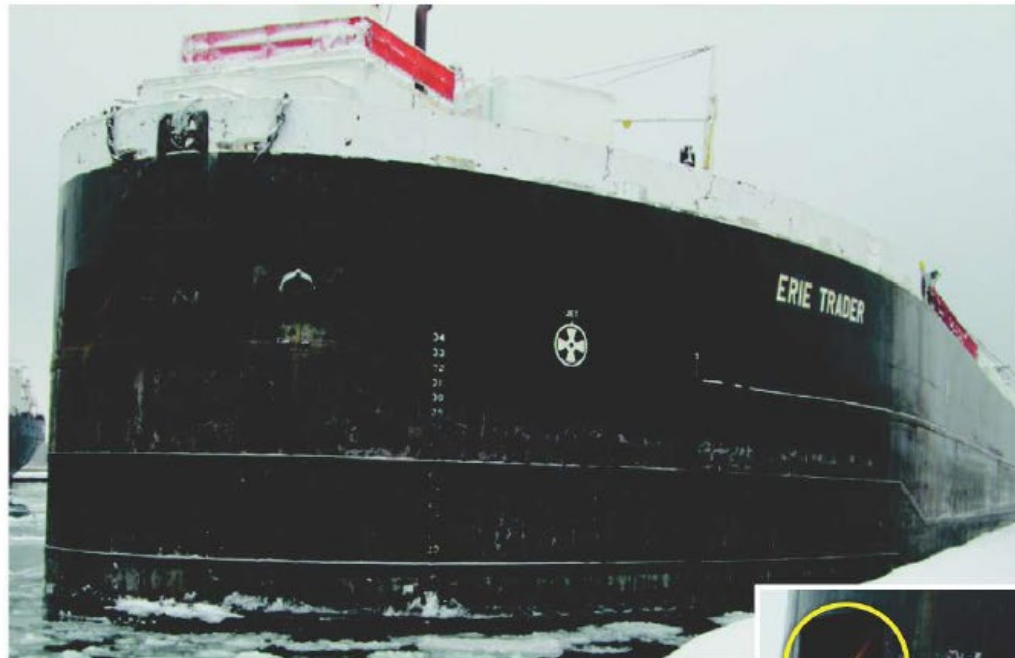
Figure 60. The bow of barge *Erie Trader* after the accident. At right: the remnant shank of the starboard anchor in the anchor pocket is highlighted. SOURCE: COAST GUARD

The anchor likely paid out slowly until it reached the water, at which point the additional force and the increasing weight of hanging chain likely hastened the payout as the brake was overwhelmed. Although anchor windlass brakes are not intended to hold an anchor and chain indefinitely during the dynamic conditions that vessels typically encounter on voyages, a properly adjusted brake should have had ample holding capacity for the weight of the *Erie Trader's* anchor and chain. However, during the postaccident teardown and replacement of the *Erie Trader's* starboard anchor windlass brake-band liners, the brake band had to be adjusted to ensure proper contact between the liner and drum with the brake activated. Based on the friction contact pattern on the upper liner, it is likely that the chief engineer and crew who replaced the top liner over the previous winter did not properly adjust the brake band. The brake band liner and hardware were replaced without the training, supervision, or instructions to properly carry out the task and ensure appropriate adjustments. Aside from the improperly adjusted band, investigators found no other defects in the anchor assembly.

The probable cause of the anchor contact of articulated tug and barge *Clyde S VanEnkevort/Erie Trader* with underwater electricity transmission cables and oil pipelines was the failure of the anchor detail to secure the barge's starboard anchor, and the improper adjustment of the anchor brake band after the engineering crew replaced the brake liner, the combination of which allowed the anchor and chain to pay out under way.

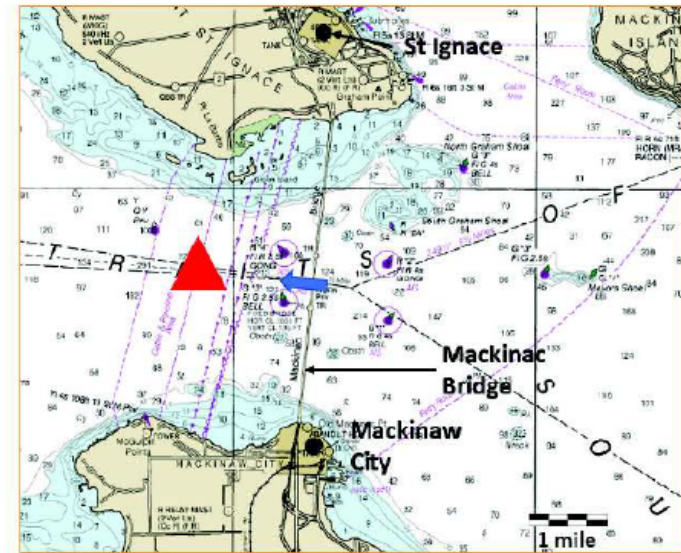
The Straits of Mackinac had underwater pipelines and transmission cables running in a general north and south direction. On April 3, the Coast Guard was notified of damage to the underwater transmission cables and the contact with the pipelines. The *Erie Trader's* starboard anchor was the likely source of the damage. The anchor damaged three of the six electrical cables, one could be repaired while two required complete replacement. The

anchor also struck the west leg of Enbridge's Line 5 dual pipeline, which transported crude oil from Canada to the United States, causing one minor dent in one pipeline and two minor dents in the other.

Figure 61. Section of NOAA chart 14881 showing a portion of the Straits of Mackinac. The location of contact with the underwater cables and pipelines is indicated by a red triangle. The blue arrow indicates the ATB's direction of travel. The soundings are indicated in feet.
